TECHNICAL REPORT GL-79-14

SUSCEPTIBILITY OF DISPERSIVE CLAY AT GRENADA DAM, MISSISSIPPI, TO PIPING AND RAINFALL EROSION

Edward B. Perry

September 1979

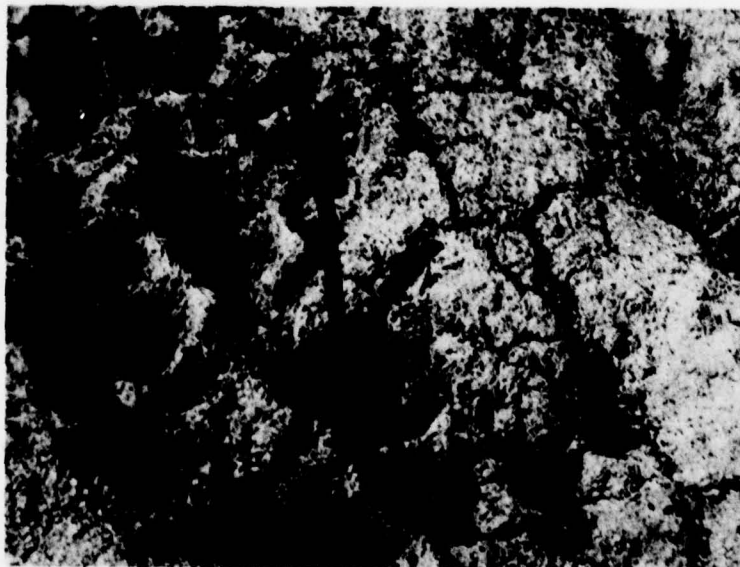
10. In May 1960, about 11 years after the completion of the main portion of the embankment, erosion patterns were documented in the excavated slope of borrow area DS (Figure 6). This erosion pattern has been reported subsequently in excavated slopes of dispersive clay in Mississippi (see Reference 14, Figure 7).

a. General view of slope showing rills

b. Close-up view of slope showing vertical erosion tunnels and surface cracking resembling a karst topography

Figure 6. Erosion pattern of excavated slope of borrow area DS,
24 May 1960 (from Reference 13)

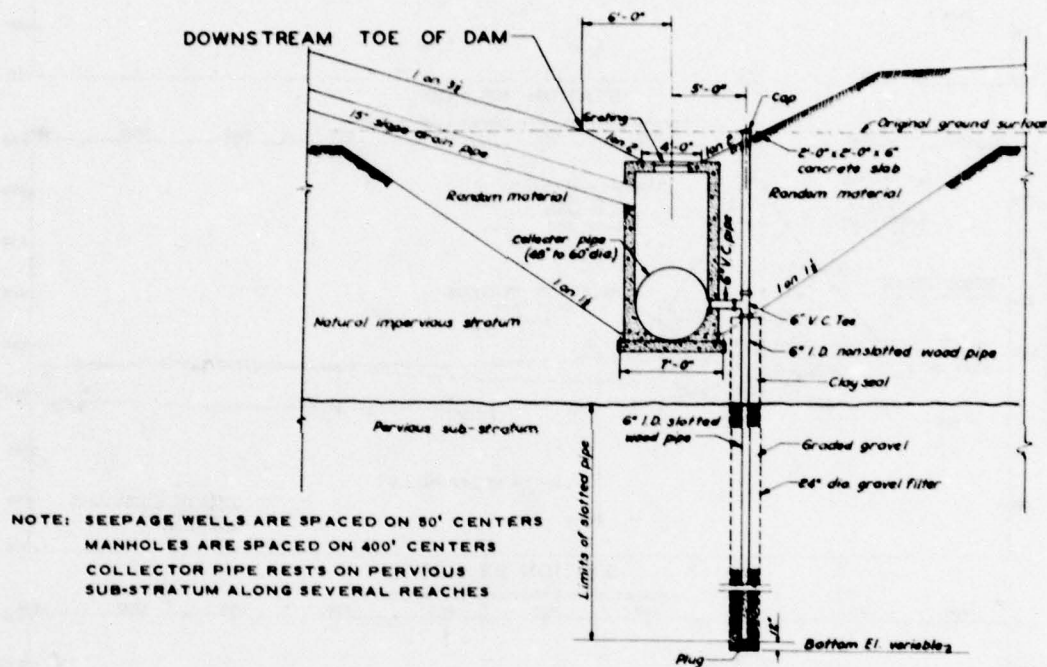
12. In February 1954, approximately a month after reservoir impounding began, fairly large cave-ins appeared over the collector pipe at sta 96+94, 98+75, and 144+86, with smaller cave-ins appearing in other locations. The reservoir was at conservation pool stage of 193.0 ft. Piezometer observations taken in April 1955 when the reservoir was at el 223, shown in Figure 8, indicate no seepage had occurred through the embankment. Inspection of the collector pipe showed piping of surrounding material through pipe joints in the vicinity of the sinks. Considerable quantities of sand and silt had been deposited in the pipe, probably as a result of the piping as well as from inwash from the downstream slope and toe road slope through the manholes. It was believed that piping through the joints of the collector pipe had been occurring for a considerable time since installation because of high groundwater level and was not the result of initial storage in the reservoir, although a rise of pool level might have accelerated the piping. Repairs were started immediately on the largest sink at sta 144+86 with excavation of the compacted fill over the pipe by open cut to approximately the top of the pipe where water was encountered. Wood sheet piling was driven in an area about 15 ft square around the pipe joint. When the excavation approached the elevation of the pipe invert, two boils appeared on the downstream side of the pipe near the joint. A boring was made and carried to el 151 on the upstream side of the pipe opposite the

Figure 7. Typical section of downstream toe drain at manhole showing collector pipe (from Reference 3)

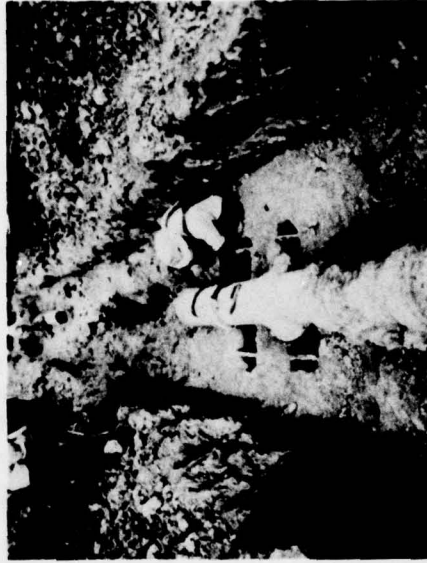
Figure 20. Repairing rainfall erosion tunnels at sta 118+00, 9 June 1958 (from File 1514-02 Subsurface Erosion, Vicksburg District)

c. Close-up side view of excavation

d. Repairing collar on slope drain pipe

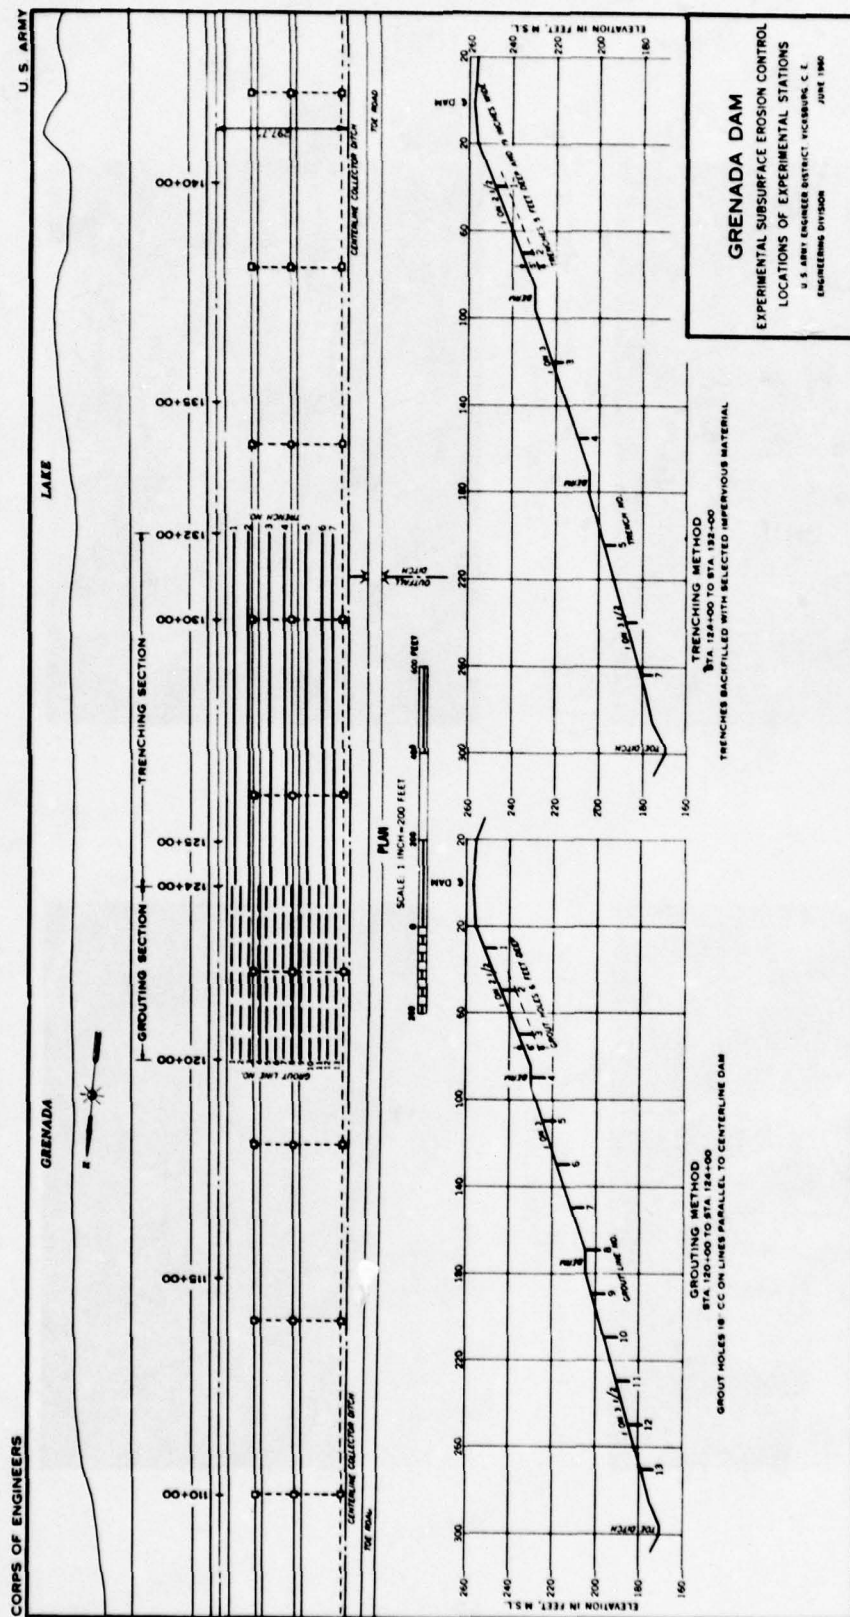
23. During May and June 1960, the second experimental method of preventing rainfall erosion tunnels was conducted. Following a suggestion made by the Greenwood Area Office in February 1956, it was decided to place barriers to the flow of water in the horizontal erosion tunnels.²⁷ One 400-ft section of the downstream slope was modified by curtain wall grouting between sta 120+00 and 124+00 and one 800-ft section by clay-filled trenches between sta 124+00 and 132+00 with locations shown in Figure 23. Curtain wall grouting was conducted by drilling 13 parallel lines about 20 ft apart of 2-in.-diam by 6-ft-deep holes on 18-in. centers placed longitudinally along the downstream slope of the dam between the crown and the toe (Figure 24). A grout mixture of silt with 7.5 percent granular bentonite by volume was used with the end of the grout pipe near the bottom of the hole and top of the hole plugged for about 1 ft by an enlarged section of the pipe. Granular bentonite was used in the grout mixture for its ability to swell later when surface drainage seeped into the horizontal erosion tunnels. The silt and bentonite were premixed in a small concrete mixer before being placed in the hopper of the mud-jacking machine where the minimum amount of water was added to produce a grout that was pumpable. Seven 19-in.-wide by 5-ft-deep trenches were dug with a machine approximately 35 ft apart longitudinally along the downstream slope of the dam between the crown and the toe (Figure 25). The trenches were backfilled with a lean clay (CL) and compacted in about 4-in.-thick compaction lifts using pneumatic tampers.¹³ Prior to the curtain wall grouting and clay-filled trenching

Figure 23. Location of experimental curtain wall grouting and clay-filled trenches, May - June 1960 (from Reference 13)
